Property Inspection Report

2416 Lake Terr
Coral Way, Fl, 12345

Prepared by: KRC Home Inspection Company
8589 SW 22 Ct
Miramar, FL 33025
954-962-4272

Inspection Date: 08/15/2009

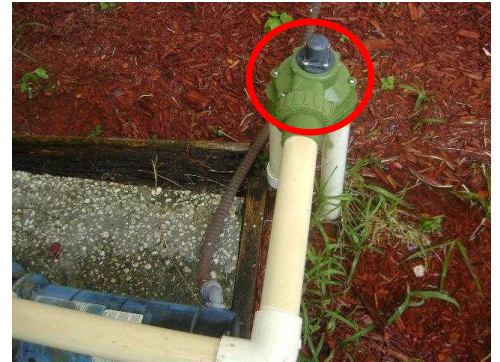
Acceptable: **Lawn Sprinklers:** Front and back yard Comments > **Leaking at zone valve, no effect on the system**

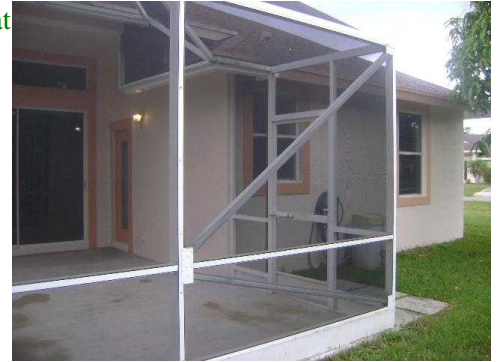
Marginal **Porch Size:** Large, Screened Comments > **Damaged screens (at least 3 panels)**

Cost to Replace Low: \$ 200 - High: \$ 300

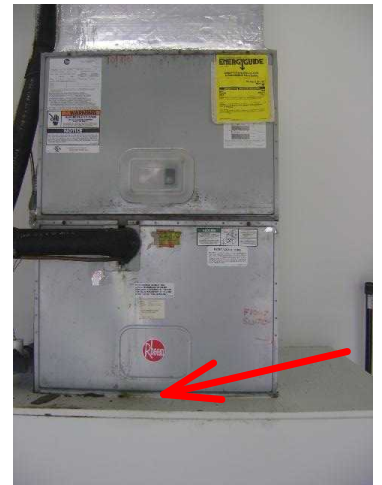
- Acceptable: **A/C System Operation:** Appears serviceable
Acceptable: **Condensate Removal:** PVC
Acceptable: **Exterior Unit:** Left of house
Acceptable: **Air handler/Filter:** Garage Area Comments > **Some rust noted at air handler, monitor**

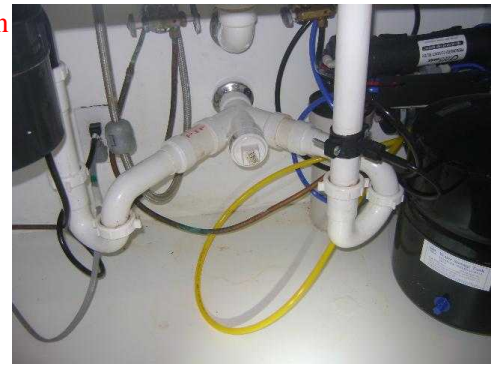
Acceptable: **Dishwasher:** Frigidaire **Approx Age:**
Acceptable: **Refrigerator:** Whirlpool **Approx Age:**
Acceptable: **Micro wave:** Frigidaire **Approx Age:** 2002
Ventilator:
Acceptable: **Dis pos al:** In-Sinkerator
Acceptable: **Sink:** Double - Stainless Steal
Acceptable: **Lighting:**
Acceptable: **Electric Outlets:** 110 VAC GFCI
Defective: **Faucet/Traps:** Faucet with PVC trap Comments > Sink drain
is leaking
Cost to Repair Low: \$ 100 - High: \$ 150

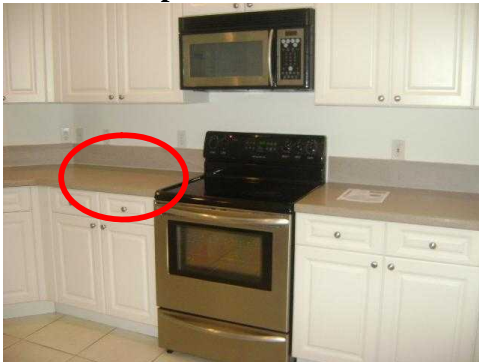
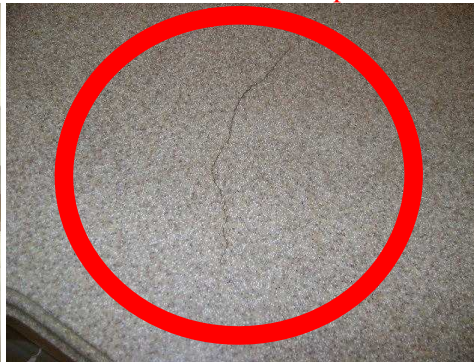
Defective: **Counter Tops:** Granite Comments > Crack noted - obtain repair cost if necessary

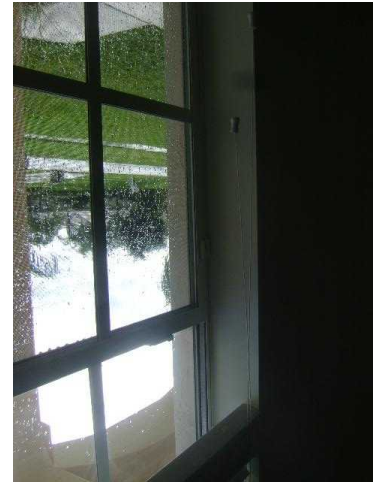
Defective: **Window Type:** Single Hung Comments > Evidence of water intrusion, Replace broken window balances
Cost to Replace Low: \$ 100 - High: \$ 200

Notes: There were signs of water intrusion at the window. This is a moderate to serious issue. Water intrusion into the structure can lead to mold growth and other problems. Removing water-damaged materials for repair or replacement may reveal further damage and microbial growth. Recommend maintenance/repair by a licensed contractor.

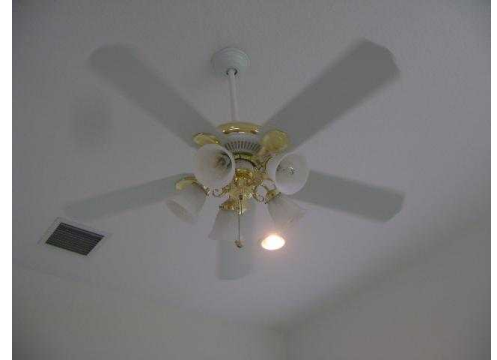
Acceptable: **Ceiling Fan:** Fan wobbles during operation / adjust balances

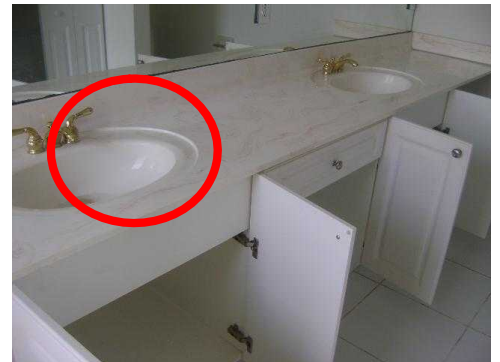
Acceptable: **Closet:** Linnen closet
Acceptable: **Ceiling Type:** Drywall
Acceptable: **Wall Type:** Drywall
Marginal **Floor Covering:** Ceramic tile Comments > Loose / uplifted floor tiles noted
Acceptable: **Entry Doors:** Hollow wood Comments > Adjust / repair lock set
Acceptable: **Window Type:** Single Hung
Acceptable: **Lighting:**
Acceptable: **Electric Outlets:** 110 VAC GFCI
Marginal **Counter/Cabinet:** Marble, Laminate and composite material Comments > Counter top appears too short for the cabinet, and water is running off the top on to the cabinet and is causing deterioration
Defective: **Sink/Basin:** Two single sinks Comments > Left sink not draining properly - further review/repair
Cost to Repair Low: \$ 75 - High: \$ 100

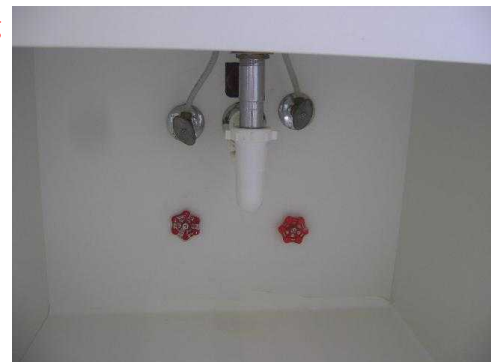
Defective: **Faucets/Traps:** Faucet with PVC Trap Comments > Leaking drain line under left sink
Cost to Repair Low: \$ 75 - High: \$ 100

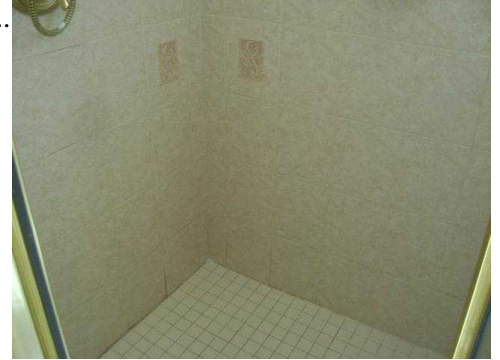
Not Present: **Spa Tub/Surround:**
Acceptable: **Shower/Surround:** Ceramic tile pan and ceramic tile surround
Comments > **Maintenance: Re-grout tile joints as needed**

Notes: The grout is deteriorated / missing at shower wall. This is a maintenance issue. Deteriorated or incorrectly applied grout and caulking can allow water to penetrate the structure, resulting in water damage or mold growth. Water damage or microbial growth occurring may be hidden from view. Recommend maintenance by a licensed contractor.

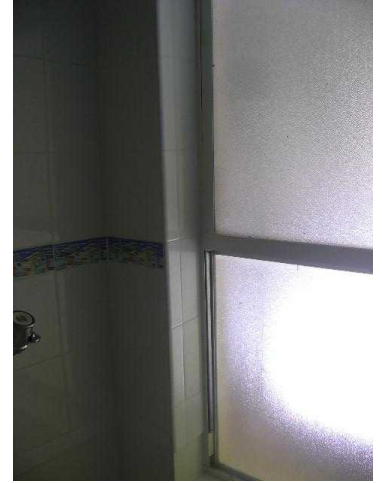
Defective: **Window Type:** Single Hung Comments > **Replace broken window balances**
Cost to Replace Low: \$ 100 - High: \$ 150

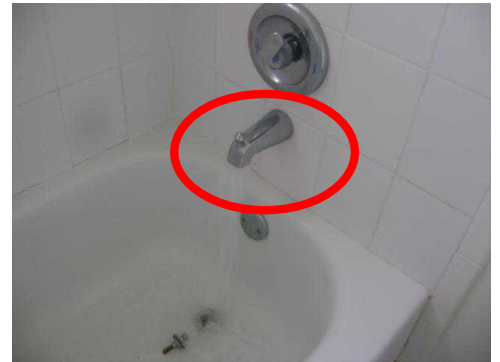
Defective: **Tub/Surround:** Steel tub and ceramic tile surround Comments > **Leaking at tub spout**
Cost to Repair Low: \$ 50 - High: \$ 75
